# National Transportation Safety Board

HWY22MH009

## **PERSONAL ELECTRONIC DEVICE (PED) - VIDEO**

Location: Clarendon Hills, Illinois  
Date: May 11, 2022  
Time: 08:16 central daylight time (CDT)  
Vehicle 1: 2004 International Truck (Del's Moving Inc.)  
Vehicle 2: METRA commuter train #1242

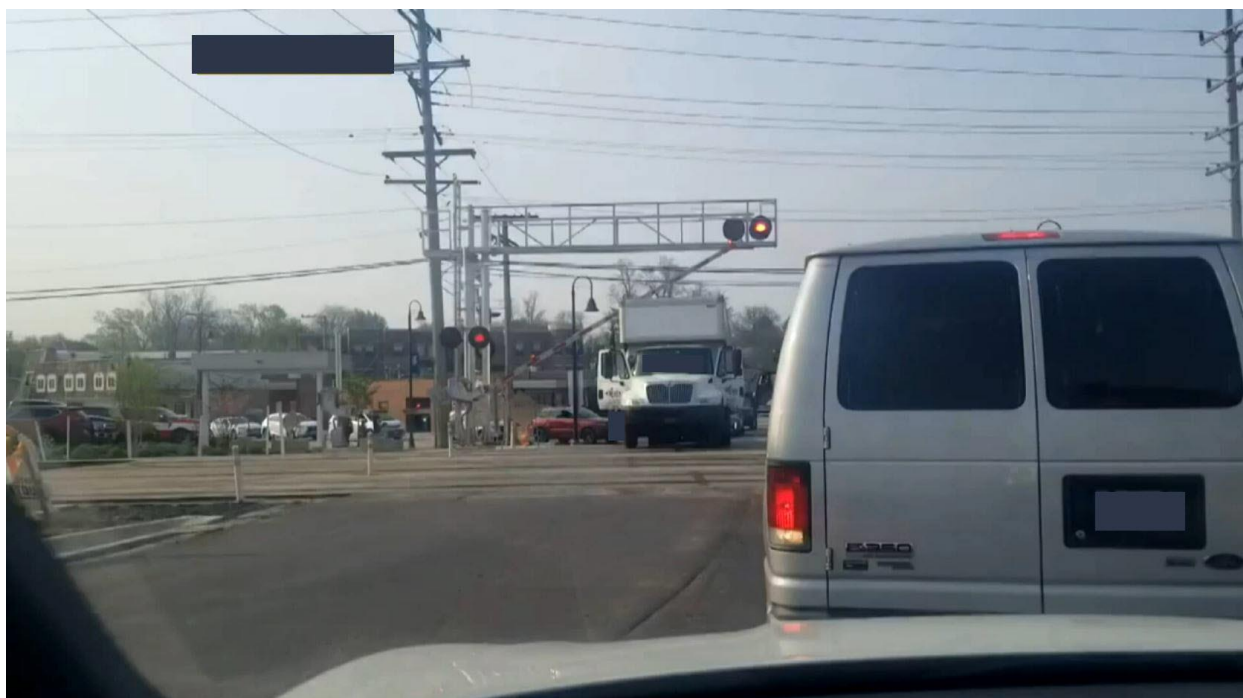
Figure 1 is a screen capture of first frame of the PED recording. The aligned time was approximately 08:16:05 CDT. The box truck is stopped on the tracks, the crossing arm had struck the box truck and was no longer moving. The crossing lights were active and flashing. Both doors of the box truck were open. A person was in the process of exiting the front right passenger door of the box truck. The legs of this person have been redacted. The train horn was sounding at the time of this screen capture. The crossing bell was also audible.

**Figure 1.** A screen capture of the first frame of the PED recording. The time was 08:16:05 CDT. The video source's name is redacted from the top left corner of the video.

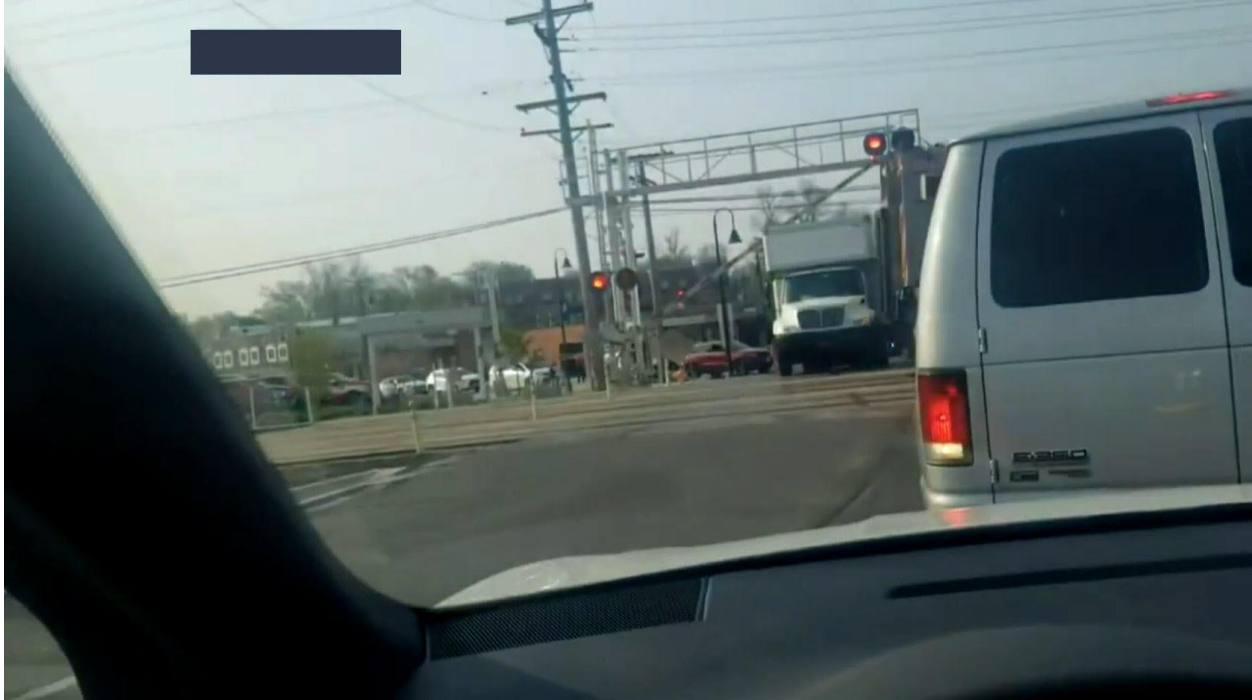
Approximately six seconds into the recording (08:16:11 CDT), the PED video had again recaptured the accident site. At this time, the train was impacting the box truck. Both of the box truck's front doors appeared to be in the closed position. Figure 2 is a screen capture at this time.

**Figure 2.** A screen capture at time 08:16:11 CDT. The video source's name is redacted from the top left corner of the video.

The train impacted the front of the box truck and pushed the front of the box truck rapidly down the tracks, resulting in a rapid pivoting motion of the box truck. Dust and debris were visible in the hood area of the box truck. The hood of the box truck appeared to detach. The point of view of the camera changed rapidly at this time.

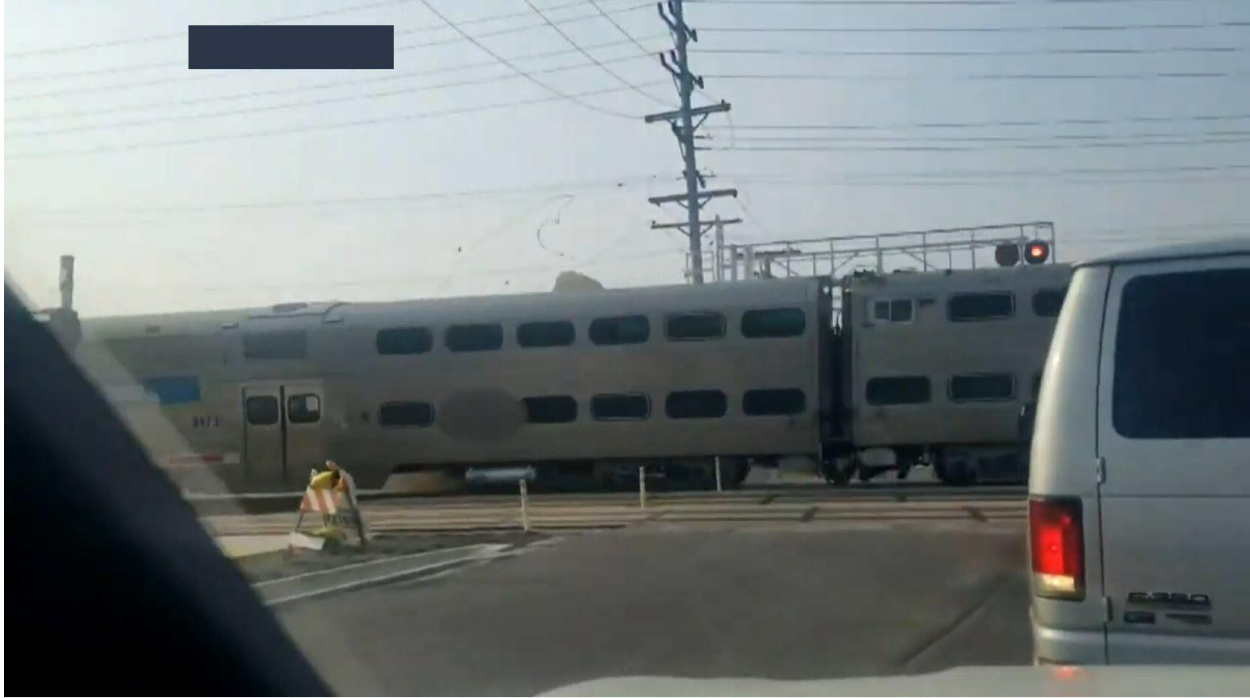
Figure 3 is a screen capture at approximately 7 seconds into the recording (08:16:12 CDT). A blurred bubble of video appeared near the lower window of the head end train car, five windows from the back of the head end train car. The unredacted version of this recording showed this was consistent with the body of the fatality being ejected from the train. Debris and a black wire were visible above the head end train car.

**Figure 3.** A screen capture at time 08:16:12 CDT. The video source's name is redacted from the top left corner of the video.

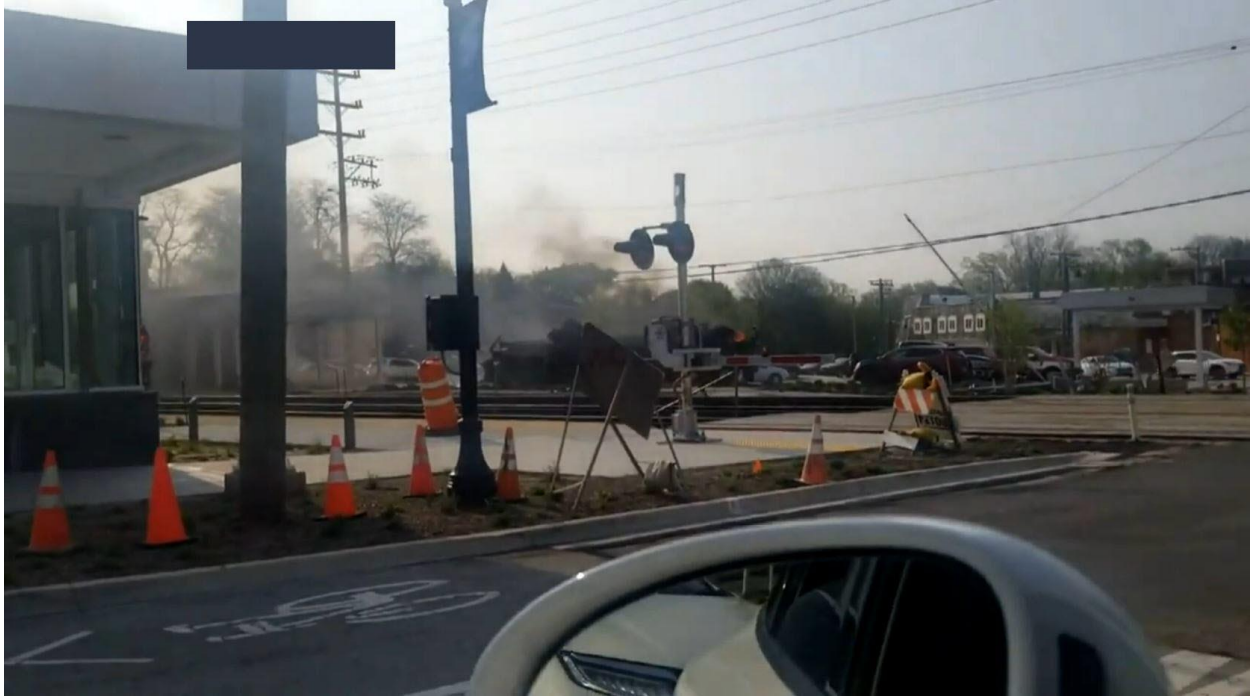
By 08:16:23 CDT, the end of the train had passed out of view. Some orange flame was visible on the far side of the tracks. Figure 4 is a screen capture at this time.

**Figure 4.** A screen capture at time 08:16:23 CDT. The video source's name is redacted from the top left corner of the video.
